At 2014.30hr Rome control cleared the Comet, which was on a scheduled flight from London to Johannesburg, to descend from Giglio direct to Civitavecchia. At 2027.30hr the Comet was cleared to establish radio contact with Rome approach. At 2028hr the aircraft advised that it had flown over Civitavecchia at 2027hr and was descending through 13,500ft heading for Fiumicino NDB, which it estimated at 2031hr. Rome approach cleared the Comet for flight of Fiumicino NDB at 1,300ft for a direct approach and to establish radio contact with Fiumicino Tower. At 2029.30hr the aircraft reported that it was descending through 9,000ft and estimating Fiumicino NDB(NF) *in one minute* (report's italics). A few minutes later the aircraft struck trees at 1,740ft about 60 miles from the airport.

The recommendations of the report are:—

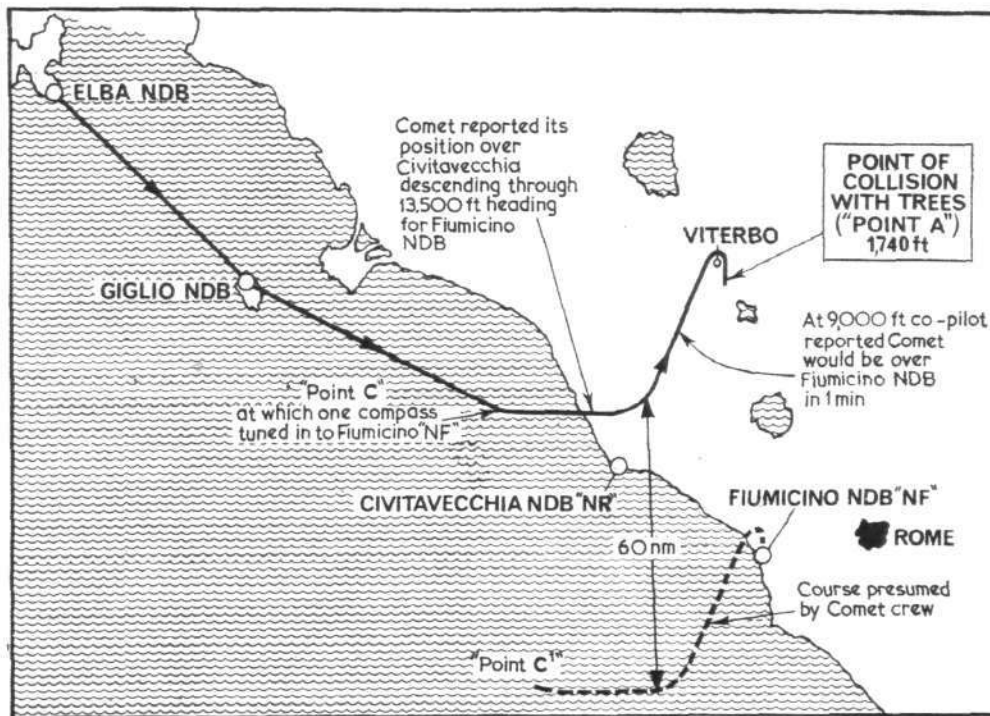
On reaching point C the pilot deviated from the track between Giglio NDB and Civitavecchia NDB and followed the indications of the radio compass needle. In so doing he thought he was on the route which is shown by a dotted line on the map, beginning at point C¹ and ending over Fiumicino NDB. This route is the same as C...A but displaced in a direction parallel to the latter by a distance of 60 n.m. A superficial critical examination of the situation could have revealed the erroneous conviction. In fact:—

(a) The time required to reach point C¹ from Giglio would have been about twice that required to reach point C and the heading some 25° to 30° greater in magnitude.

(b) The whole of the route would have been flown over the sea, whereas it was observed both with the aircraft radar and by direct observation that the aircraft passed over the coastline and subsequently flew over land.

(c) If the aircraft had followed the route C¹ to Fiumicino NDB, Civitavecchia NDB would always have been observed on the port side, whereas the crew saw it "go round" to starboard.

From the whole of the above considerations, it is deduced that the aircraft did not in any event fly over Civitavecchia NDB and therefore the communication made at 2028hr relating to such overflight is without foundation on fact.

The probable track of the Comet (see text) is shown in this illustration, which is based on that included in the Italian accident report. The original shows a second possible final course a little to the south of that indicated by the full line on this map
