## Fatal accidents:

# Scheduled passenger flights

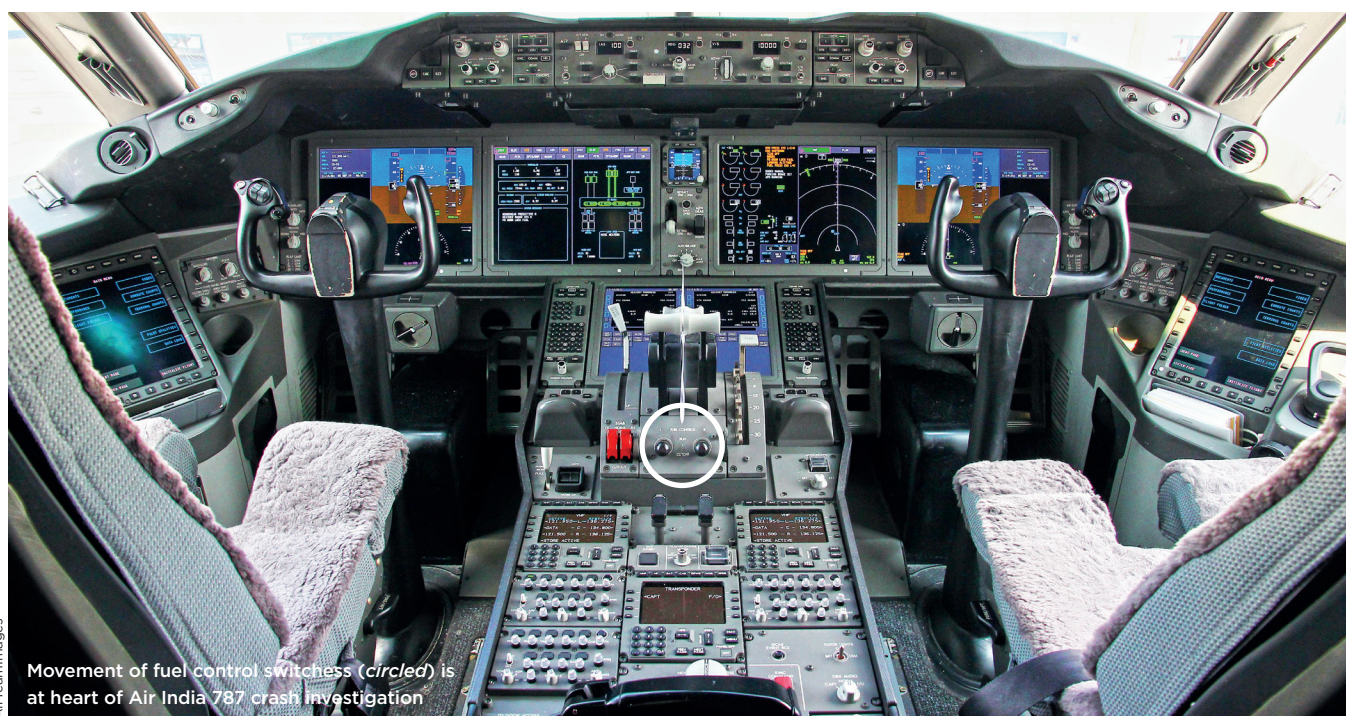
co-pilot was the pilot flying, with the captain the pilot monitoring. "When fuel control switches are moved from Cut Off to Run while the aircraft is airborne, each engine's full authority digital engine control automatically manages a relight and thrust recovery sequence of ignition and fuel introduction," the report states. "The EGT [exhaust gas temperature] was observed to be rising for both engines, indicating relight. Engine 1's core deceleration stopped, reversed and started to progress to recovery. Engine 2 was able to relight but could not arrest core speed deceleration and re-introduced fuel repeatedly to increase core speed acceleration and recovery." The 787's undercarriage was never selected up, with the slow descent resulting in collision with accommodation buildings for a local hospital, after only 32s airborne. The aircraft broke up and caught fire. One passenger was a lone survivor, while a further 19 people on the ground were also killed.

Movement of fuel control switches (circled) is at heart of Air India 787 crash investigation

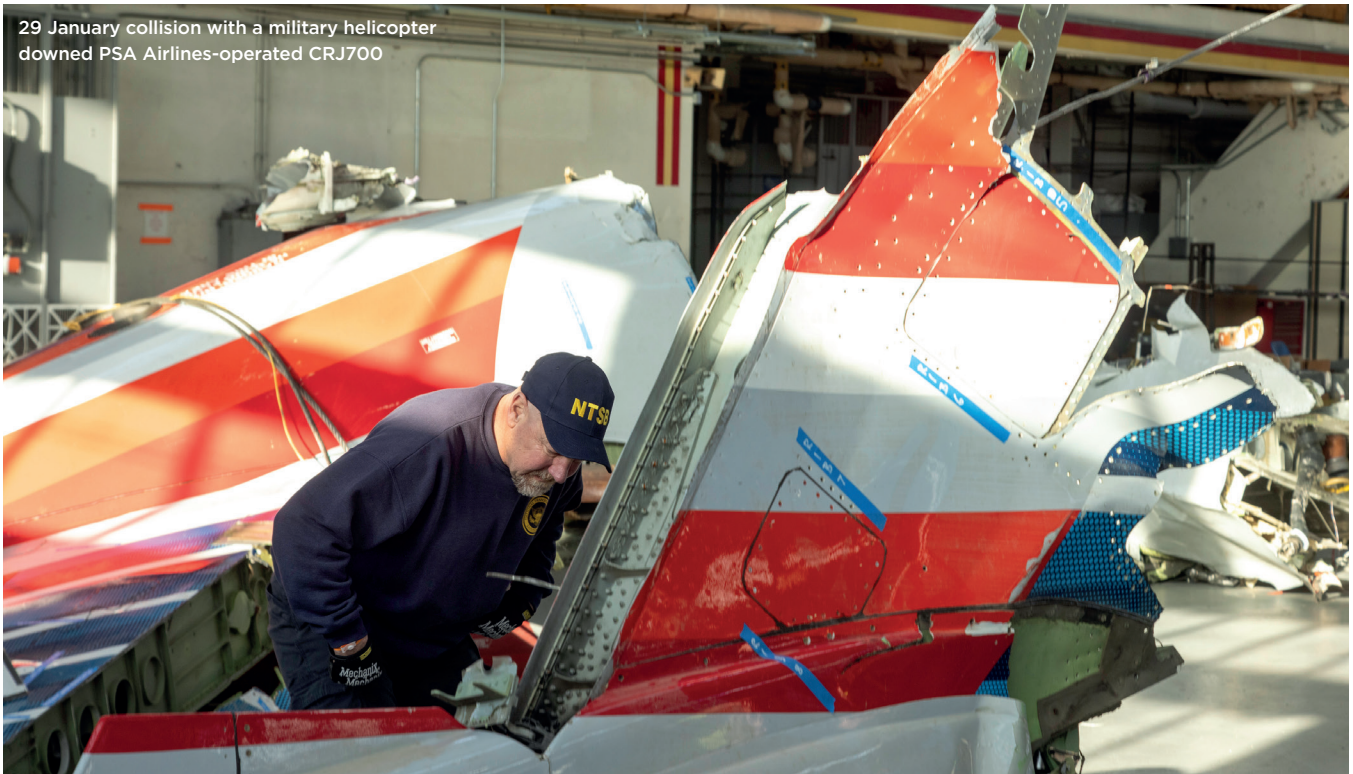
to intercept the extended centreline for runway 33, where it crosses the east bank of the Potomac. Meanwhile, a US Army crew flying a Sikorsky UH-60 Black Hawk under visual flight rules on a training flight was flying south on Helicopter Route 1 to join Route 4, and reported to Reagan tower that they were at 300ft. The CRJ700ER and the helicopter collided at 20:48, while the former was on final approach to runway 33. All the people aboard the jet lost their lives, along with the three personnel who were on the military helicopter.

29 January collision with a military helicopter  
downed PSA Airlines-operated CRJ700

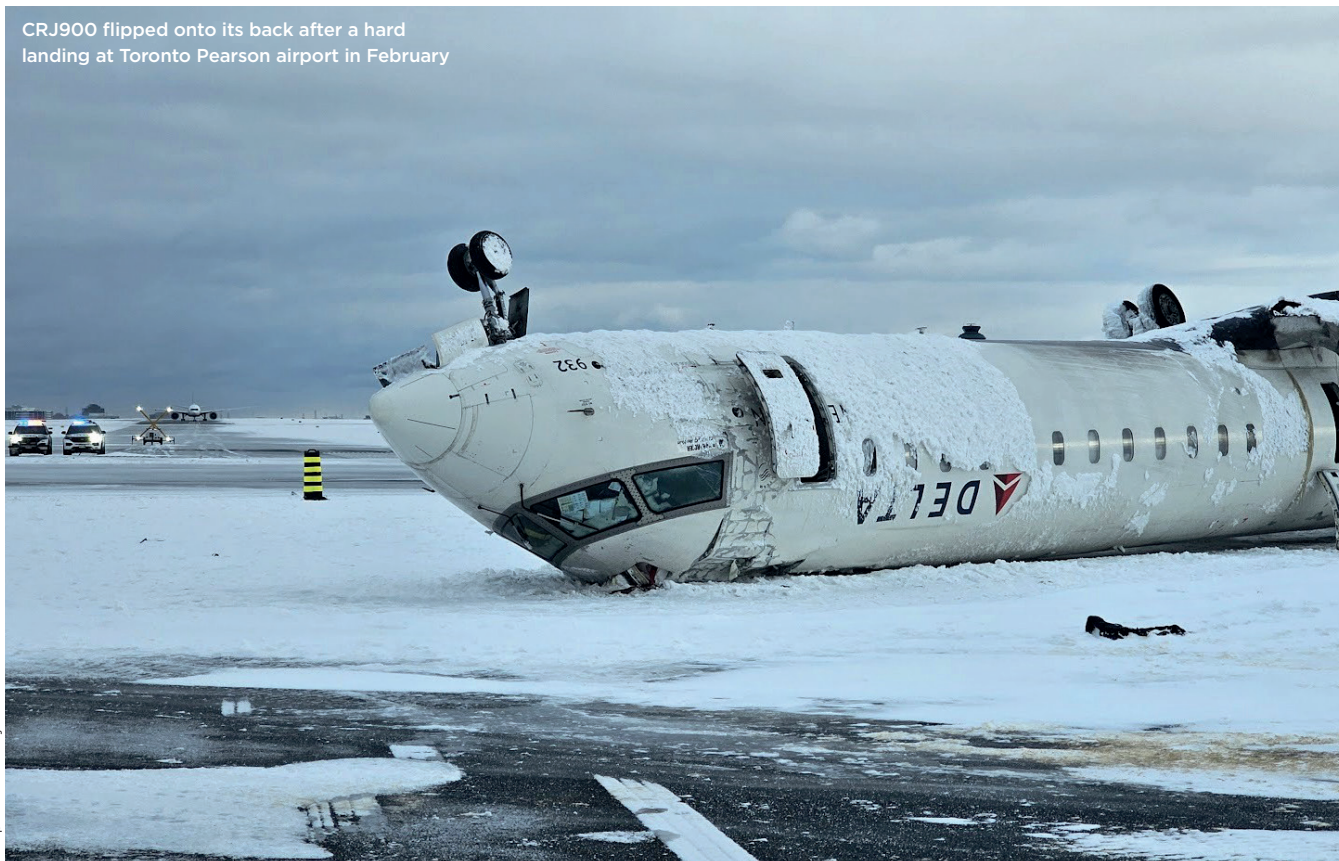
Meanwhile, the rate of descent gradually increased from about 700ft/min to more than 1,000ft/min, and at touchdown the aircraft was banked 7° to the right. The right main landing gear collapsed on contacting the runway as a result of a 3g vertical deceleration; the right wing broke at the wing root, releasing fuel, and it soon detached completely; and the aircraft flipped onto its back, causing the empennage to separate. The aircraft slid along runway 23 before veering off it onto snow-covered grass, and came to a halt near the intersection with runway 23.

CRJ900 flipped onto its back after a hard landing at Toronto Pearson airport in February

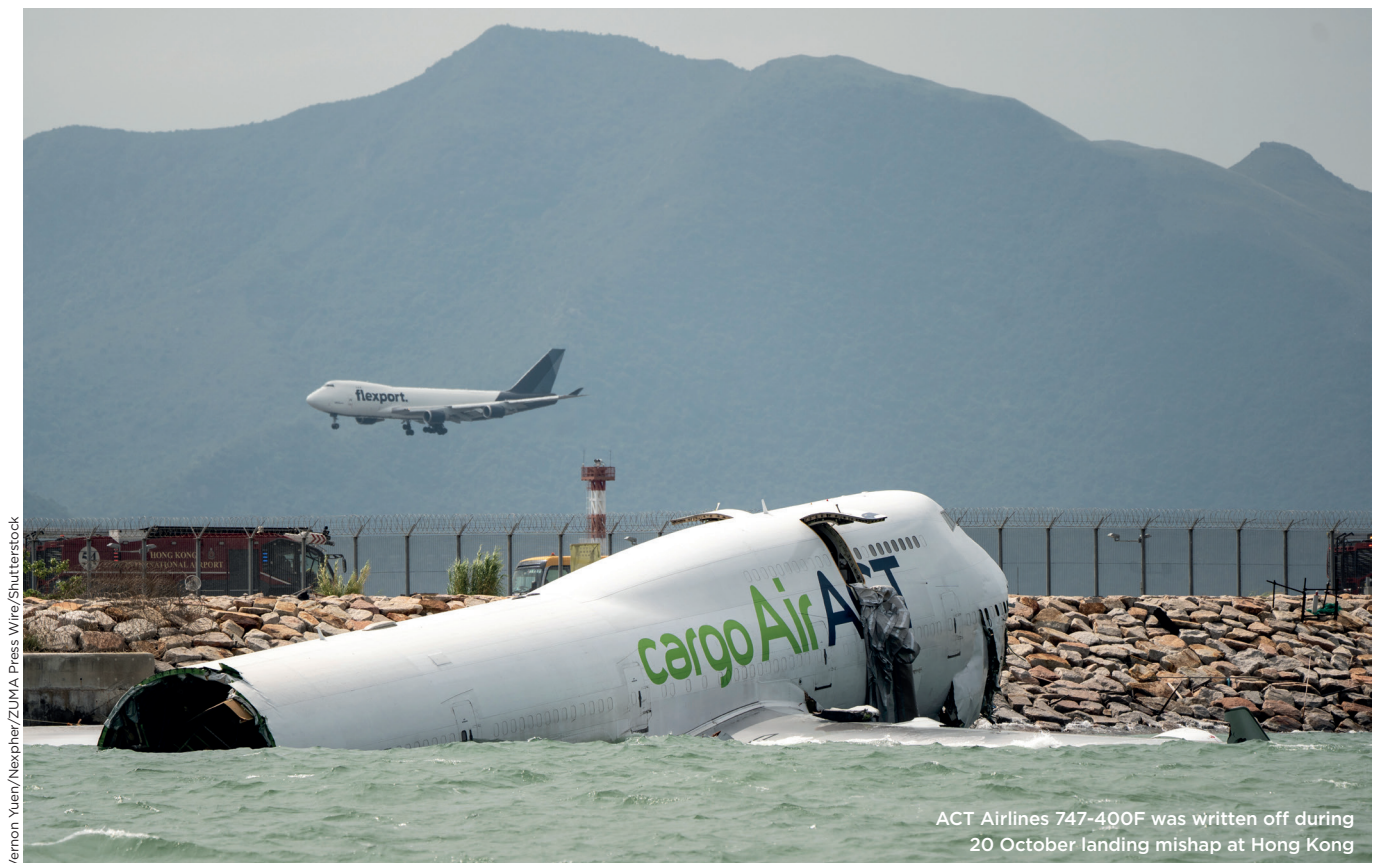
Inbound from Dubai World Central, operated by ACT for Emirates SkyCargo, the aircraft landed apparently normally on runway 07L at 03:50 local time, but some distance into its ground run it veered left off the runway, ran through fencing and across the perimeter road and into the sea, with the fuselage fracturing as it did so. The aircraft hit a security patrol vehicle on the perimeter road, killing both occupants. The Hong Kong Accident Investigation Authority says the flight-data

recorder shows that, during the landing run, the No 4 engine thrust lever moved to the fully forward position, and that this fact is a "particular focus" for the investigation. The crew knew before departure from Dubai that the No 4 thrust reverser had been logged as inoperative, and on landing had only selected reverse thrust initially on numbers 2 and 4 (at 95% NI), with idle reverse selected on engine No 1. There was no cargo on board.

ACT Airlines 747-400F was written off during 20 October landing mishap at Hong Kong

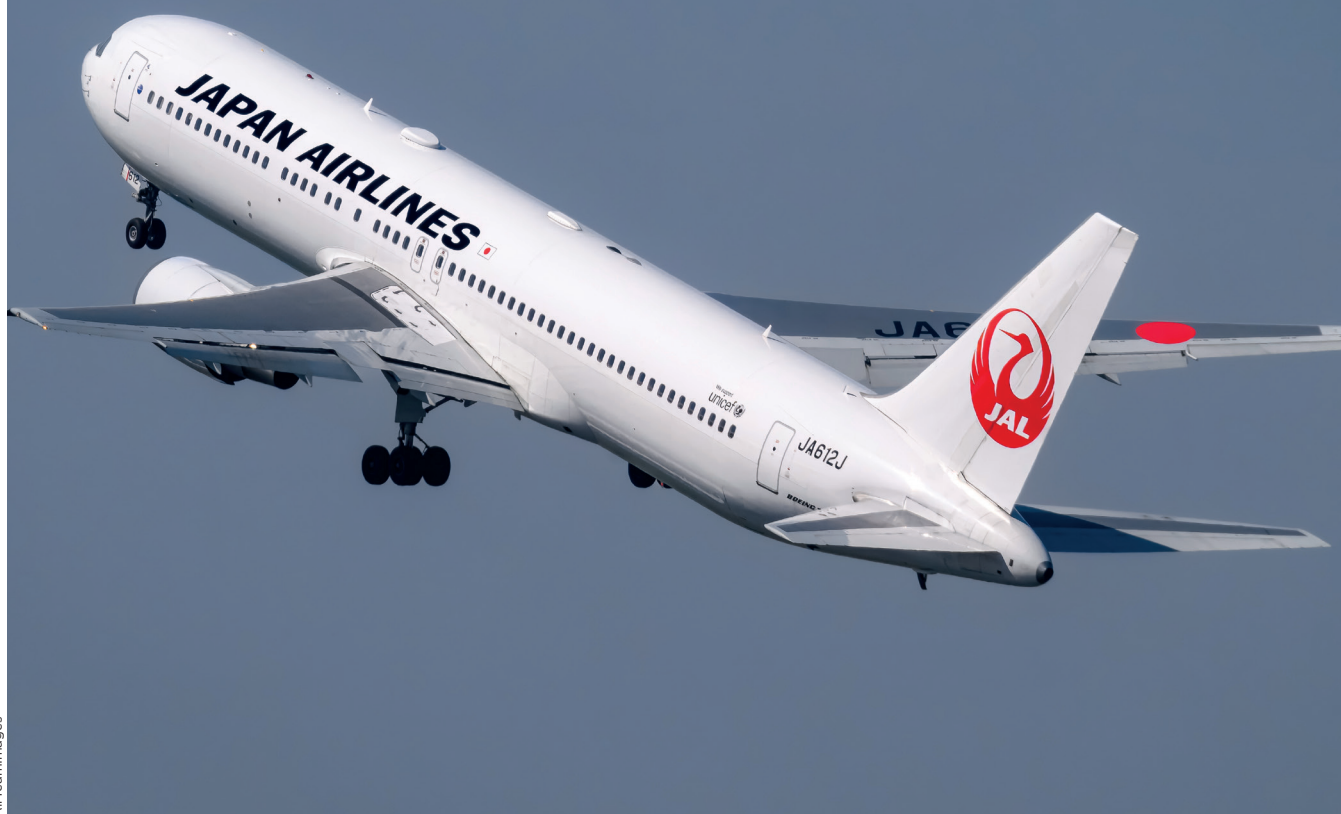
JAL 767 suffered multiple bird strikes shortly after take-off from Kagoshima in November

The aircraft suffered 'multiple bird strikes' on its No 2 engine shortly after take-off from runway 34. The crew stopped the climb at about 6,000ft and took up a holding pattern before electing to return to Kagoshima,
