Accidents and incidents 2019

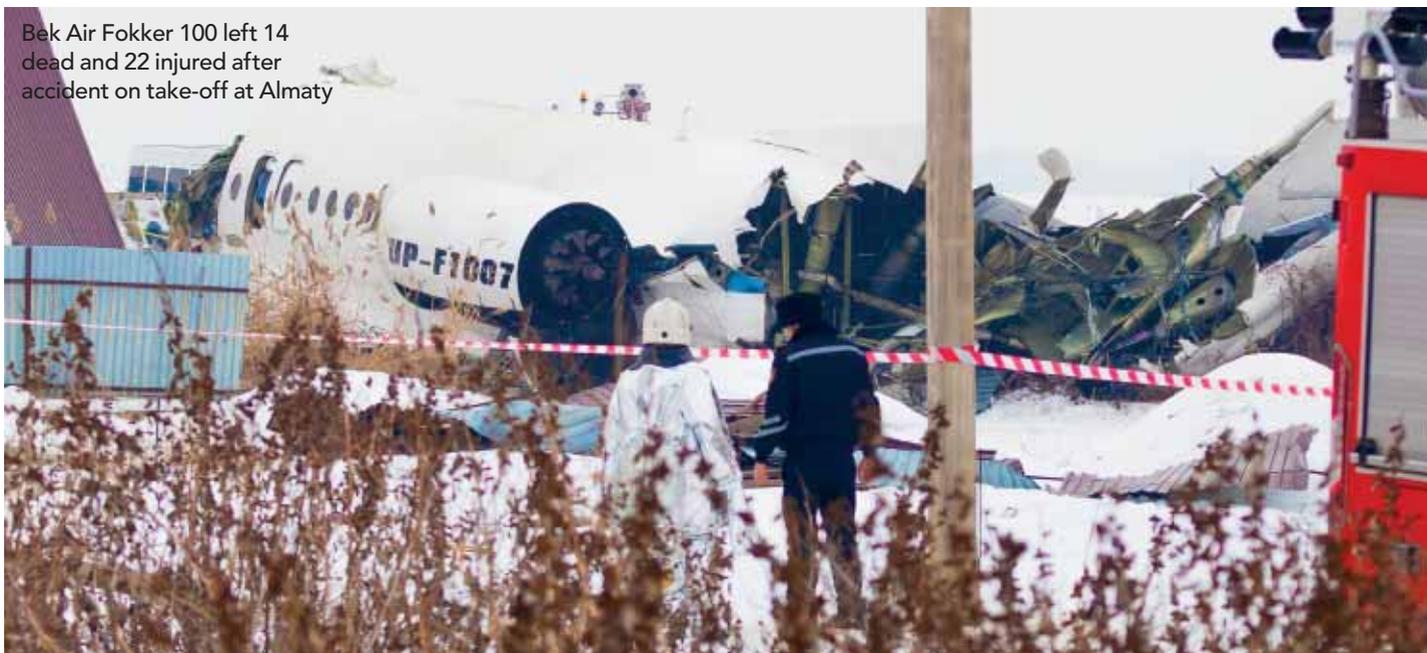
27 Dec	Bek Air	Fokker 100 (UP-F1007)	Almaty airport, Kazakhstan	14	5/96	TO
<p>The aircraft crashed almost immediately after getting airborne at 07:22 local time from runway 05R for a domestic flight to Nur-Sultan. The temperature was -12°C (10°F), dew point 13°C, there was a light wind and mist. The aircraft appears to have used more of the runway than expected to take off, and when it failed to stay airborne it crashed through an airport boundary wall and came to rest having collided with a house. There was no fire. An estimated 22 people were badly injured, but some 35 were able to walk away from the aircraft, the fuselage of which was broken in more than one place.</p>

Bek Air Fokker 100 left 14 dead and 22 injured after accident on take-off at Almaty

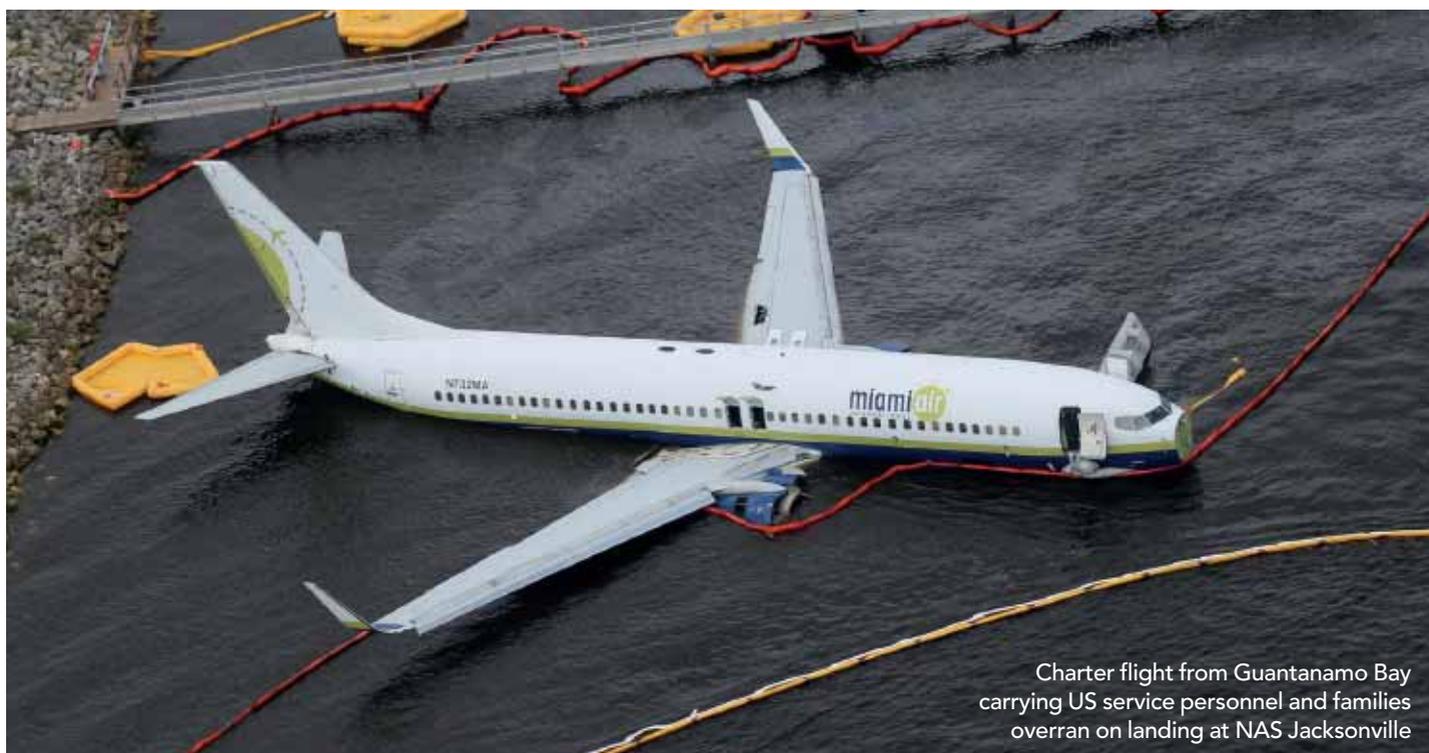
Charter flight from Guantanamo Bay carrying US service personnel and families overran on landing at NAS Jacksonville

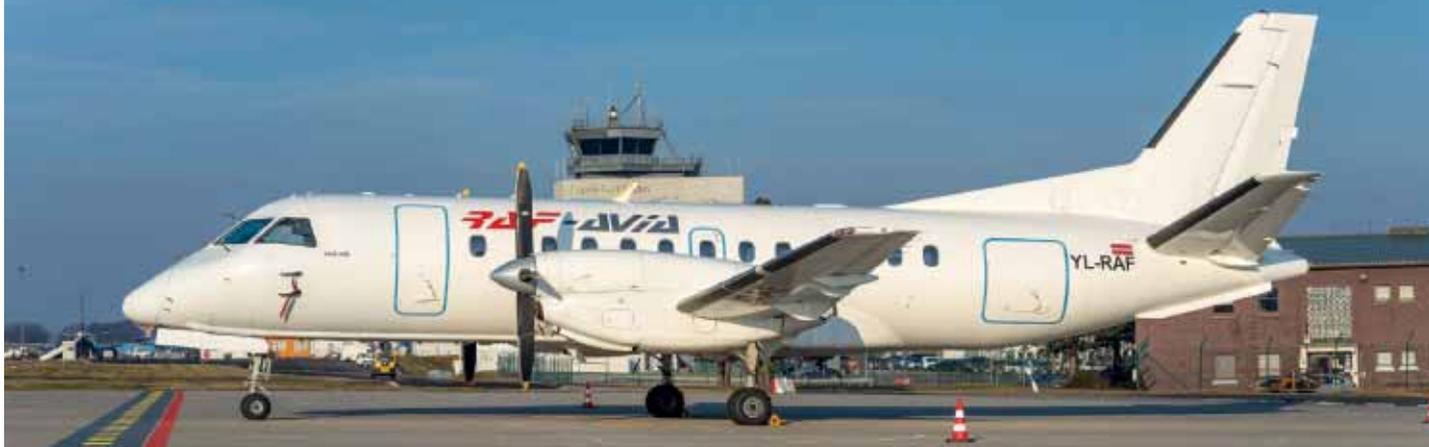
Directional control was apparently lost during the landing roll, the aircraft veered off the runway and collided with a snow bank. The accident happened in darkness (04:50 local time) and IMC. Wind 220°/5kt, visibility 2,500m in snow, cloud, broken at 500ft and overcast at 1,500ft, temperature and dew point -2°C. The aircraft was operating a positioning flight from Riga, Latvia.

Flightcrew of Saab 340 operated by RAF-Avia are thought to have lost control on landing at Savolinn

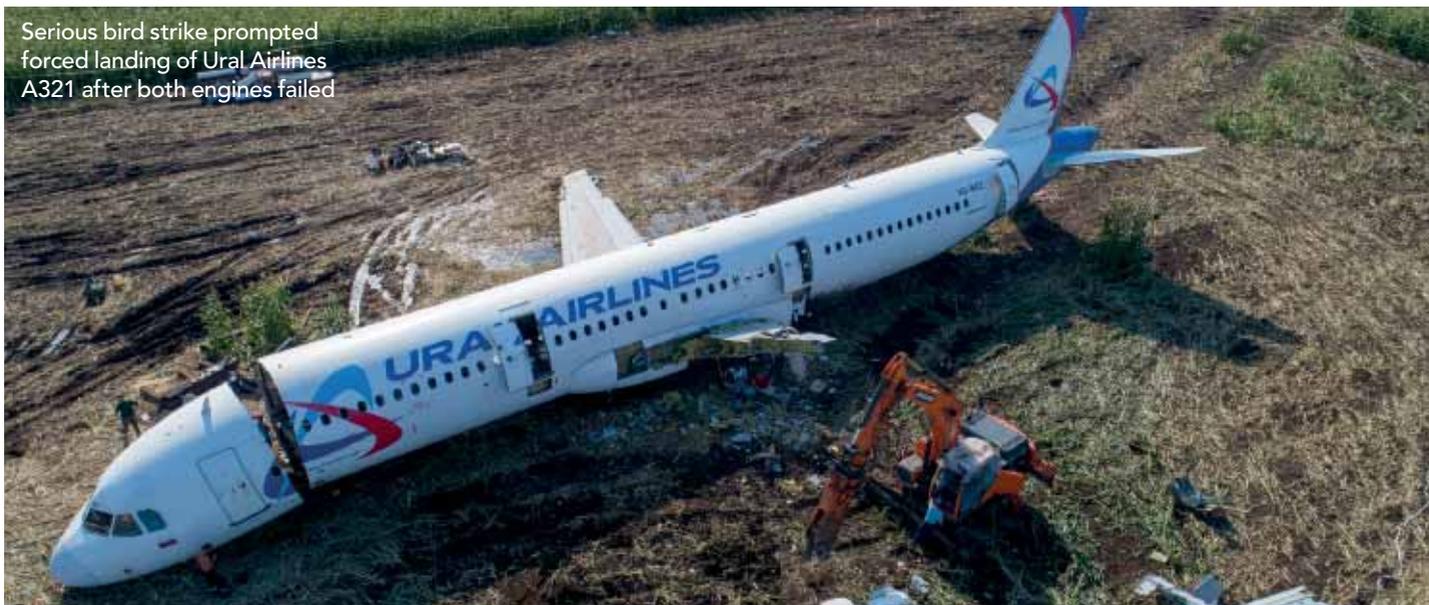
Serious bird strike prompted forced landing of Ural Airlines A321 after both engines failed
