Significant non-fatal accidents/incidents:

## All commercial airline categories

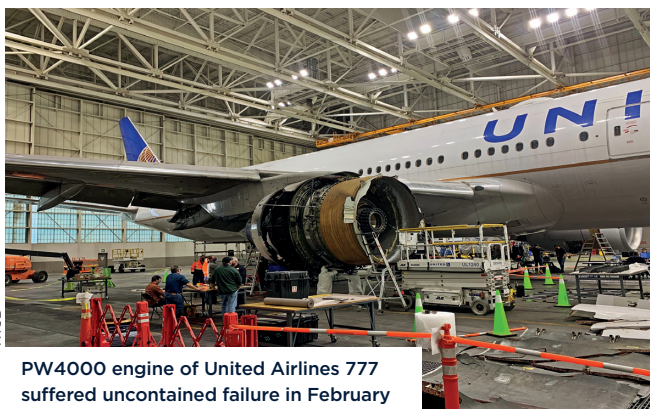
**PW4000 engine of United Airlines 777 suffered uncontained failure in February**
