Fatal accidents:

Scheduled passenger flights

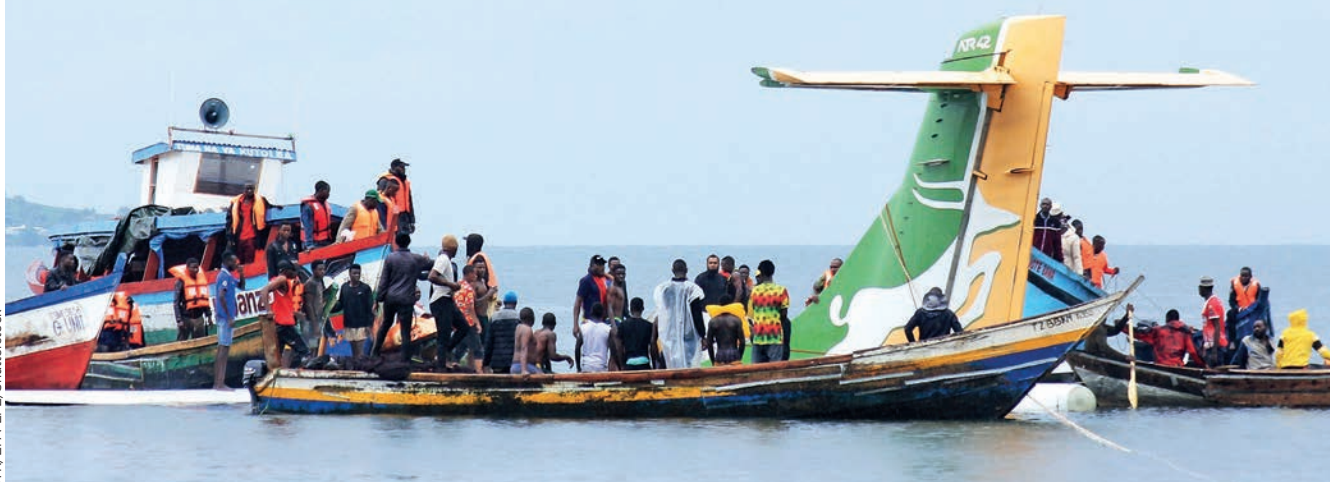
ATR 42-500 came down in Lake Victoria in November, resulting in 19 fatalities

Date: 6 Nov • **Carrier:** Precision Air • **Aircraft type/registration:** ATR 42-500 (5H-PWF) • **Location:** Near Bukoba airport, Tanzania • **Fatalities (crew/pax):** 2/17 • **Total occupants (crew/pax):** 4/39 • **Phase:** Final approach

On its final approach to runway 31 at Bukoba airport, at the end of a flight from Dar es Salaam, the aircraft came down in Lake Victoria at a distance of about 500m (1,640ft) from the runway threshold, which is

very close to the shore of the lake. The accident happened in daylight (08:45 local time) but in poor weather, with reduced visibility as a result of heavy rain.

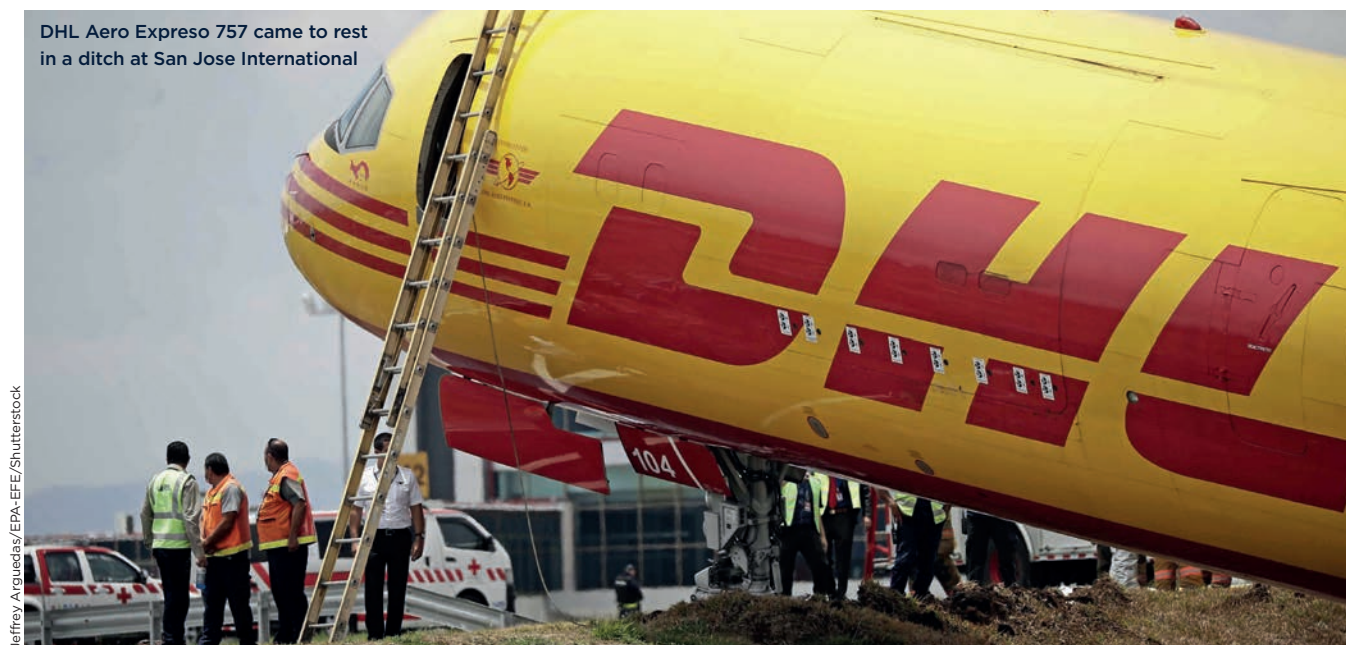
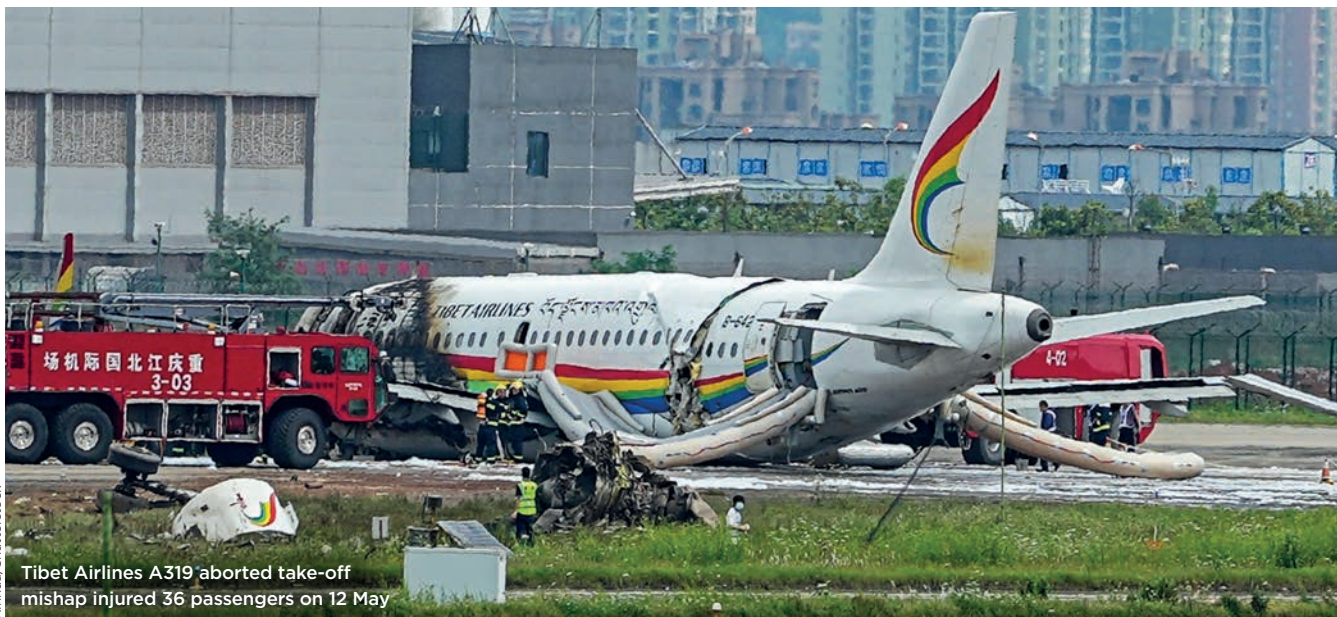
smoke appeared to be emanating from the main wheels, and the aircraft made a turn to the right that took it off the runway in what looked like a skid, the fuselage swinging rapidly to the right through more than 180°. The 757 came to rest in a ditch with its fuselage broken just forward of its tail. The visibility was good at the time of the incident, with light wind.

DHL Aero Expreso 757 came to rest in a ditch at San Jose International

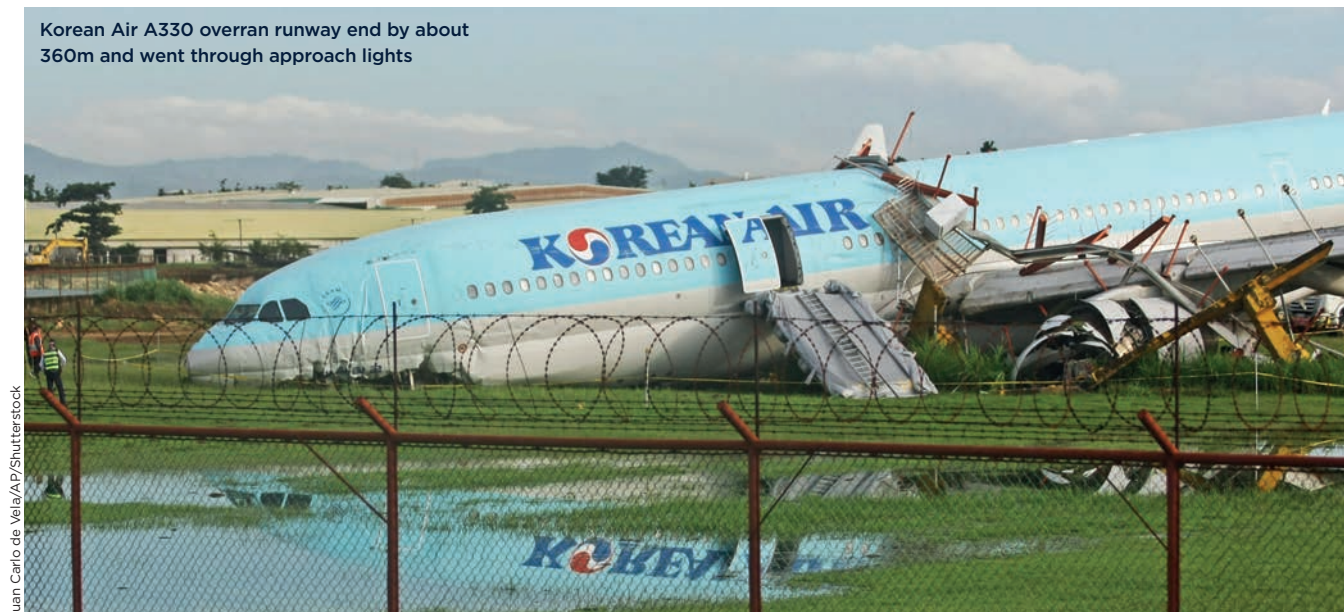
by about 360m (1,180ft) and ploughed through the approach lights and instrument landing system localiser antenna array before coming to a halt with its nosewheel collapsed. At the time of the incident the weather was stormy, with extensive cumulonimbus cloud in the airport vicinity.

Korean Air A330 overran runway end by about 360m and went through approach lights

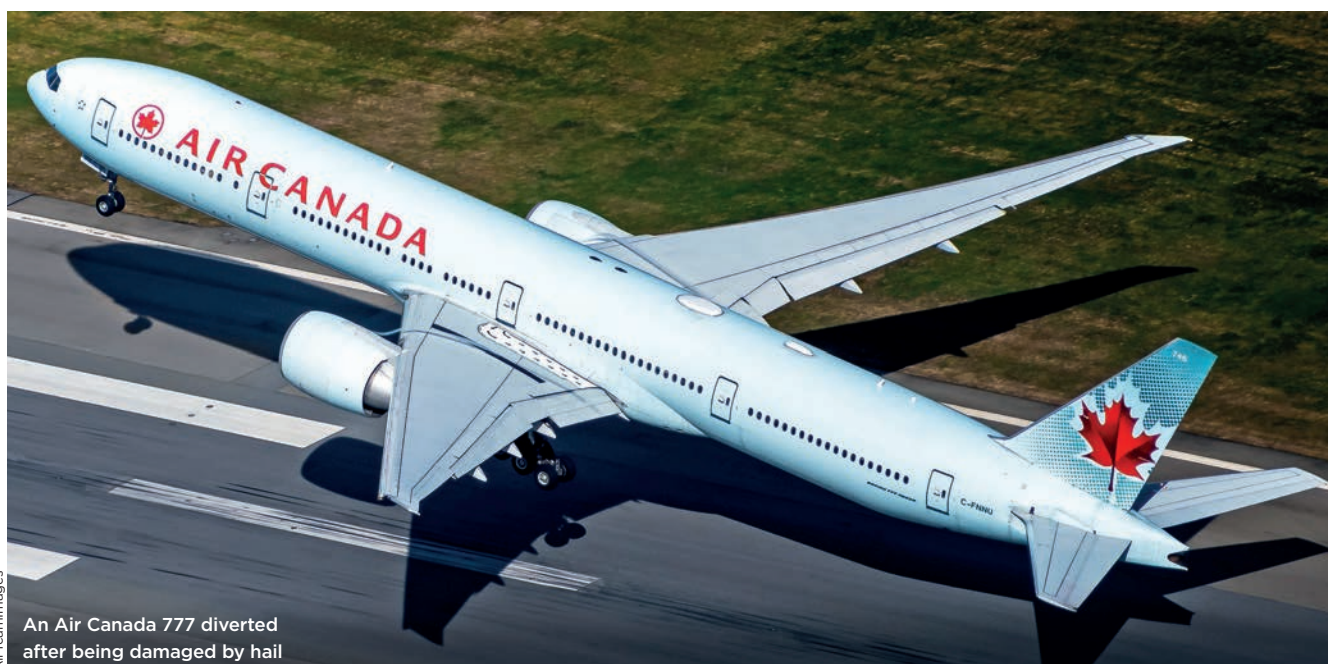
An Air Canada 777 diverted after being damaged by hail
