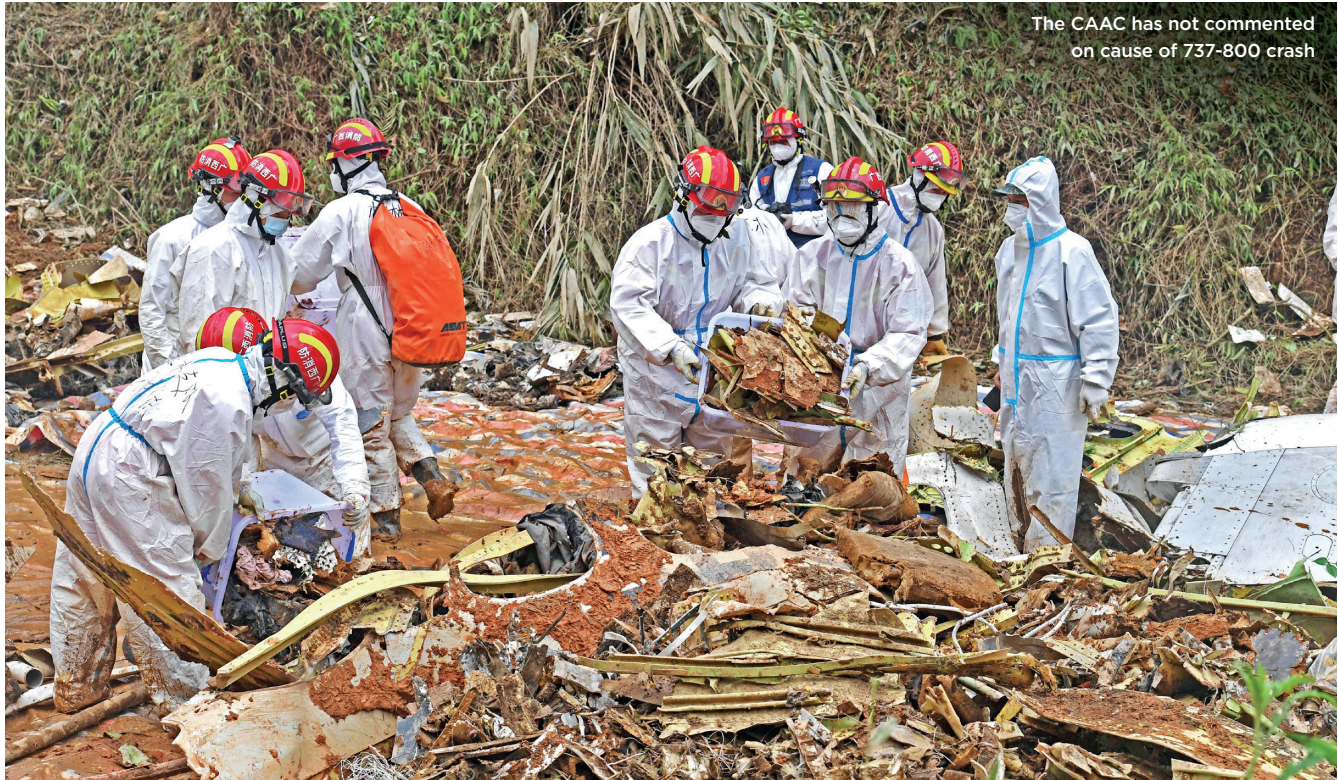
Date: 21 Mar ● **Carrier:** China Eastern Airlines ● **Aircraft type/registration:** Boeing 737-800 (B-1791) ● **Location:** Tengxian, Guangxi Province, China
Fatalities (crew/pax): 9/123 ● **Total occupants (crew/pax):** 9/123 ● **Phase:** En route

En route from Kunming to Guangzhou on a domestic scheduled flight, the aircraft was cruising normally and without incident at about 29,000ft until close to the point at which it might normally have begun the descent towards its destination airport. At that point it did indeed begin a descent, but without any communication with air traffic control (ATC), and the descent profile was very steep and at high speed. During the descent there was little deviation from the heading maintained during the cruise, and questioning calls from ATC went unanswered. A winglet from the aircraft was found some 5.4nm (10km) from the main wreckage. When the flight-data recorder and cockpit

The CAAC has not commented on cause of 737-800 crash

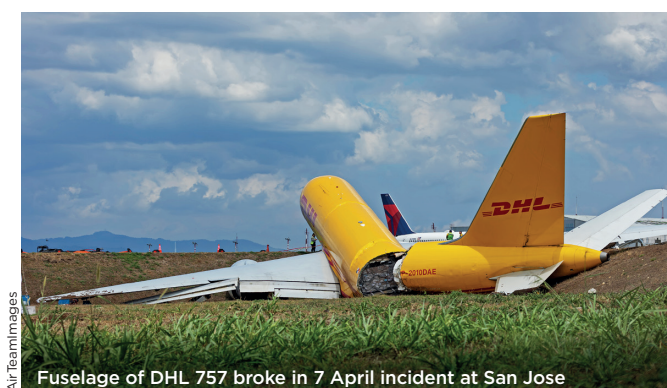
Having taken off from runway 07 at San Jose and flown about 60nm (111km) north in the direction of its intended destination at Guatemala City, the crew of the Boeing 757 initiated a return to San Jose, reportedly with hydraulic problems. After setting up a holding pattern for multiple circuits, the crew began a straight-in approach to runway 07. The touchdown appeared normal, but not far into the landing

run smoke appeared to be emanating from the main wheels, and the aircraft made a turn to the right that took it off the runway in what looked like a skid, the fuselage swinging rapidly to the right through more than 180°. The 757 came to rest in a ditch with its fuselage broken just forward of its tail. The visibility was good at the time of the incident, with light wind.

Fuselage of DHL 757 broke in 7 April incident at San Jose

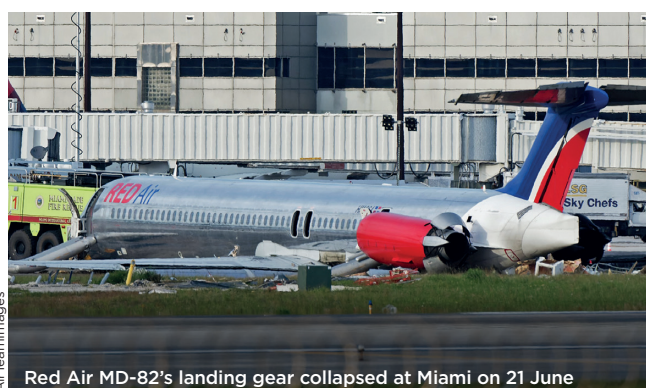
Red Air MD-82's landing gear collapsed at Miami on 21 June

Inbound from Santo Domingo, the Dominican Republic, the Boeing MD-82 suffered a left main gear collapse while landing on Miami International's runway 09. The aircraft slid off the left side of the

runway and a fire subsequently broke out in the left wing. The crew and passengers managed to complete an evacuation of the aircraft without injuries.
