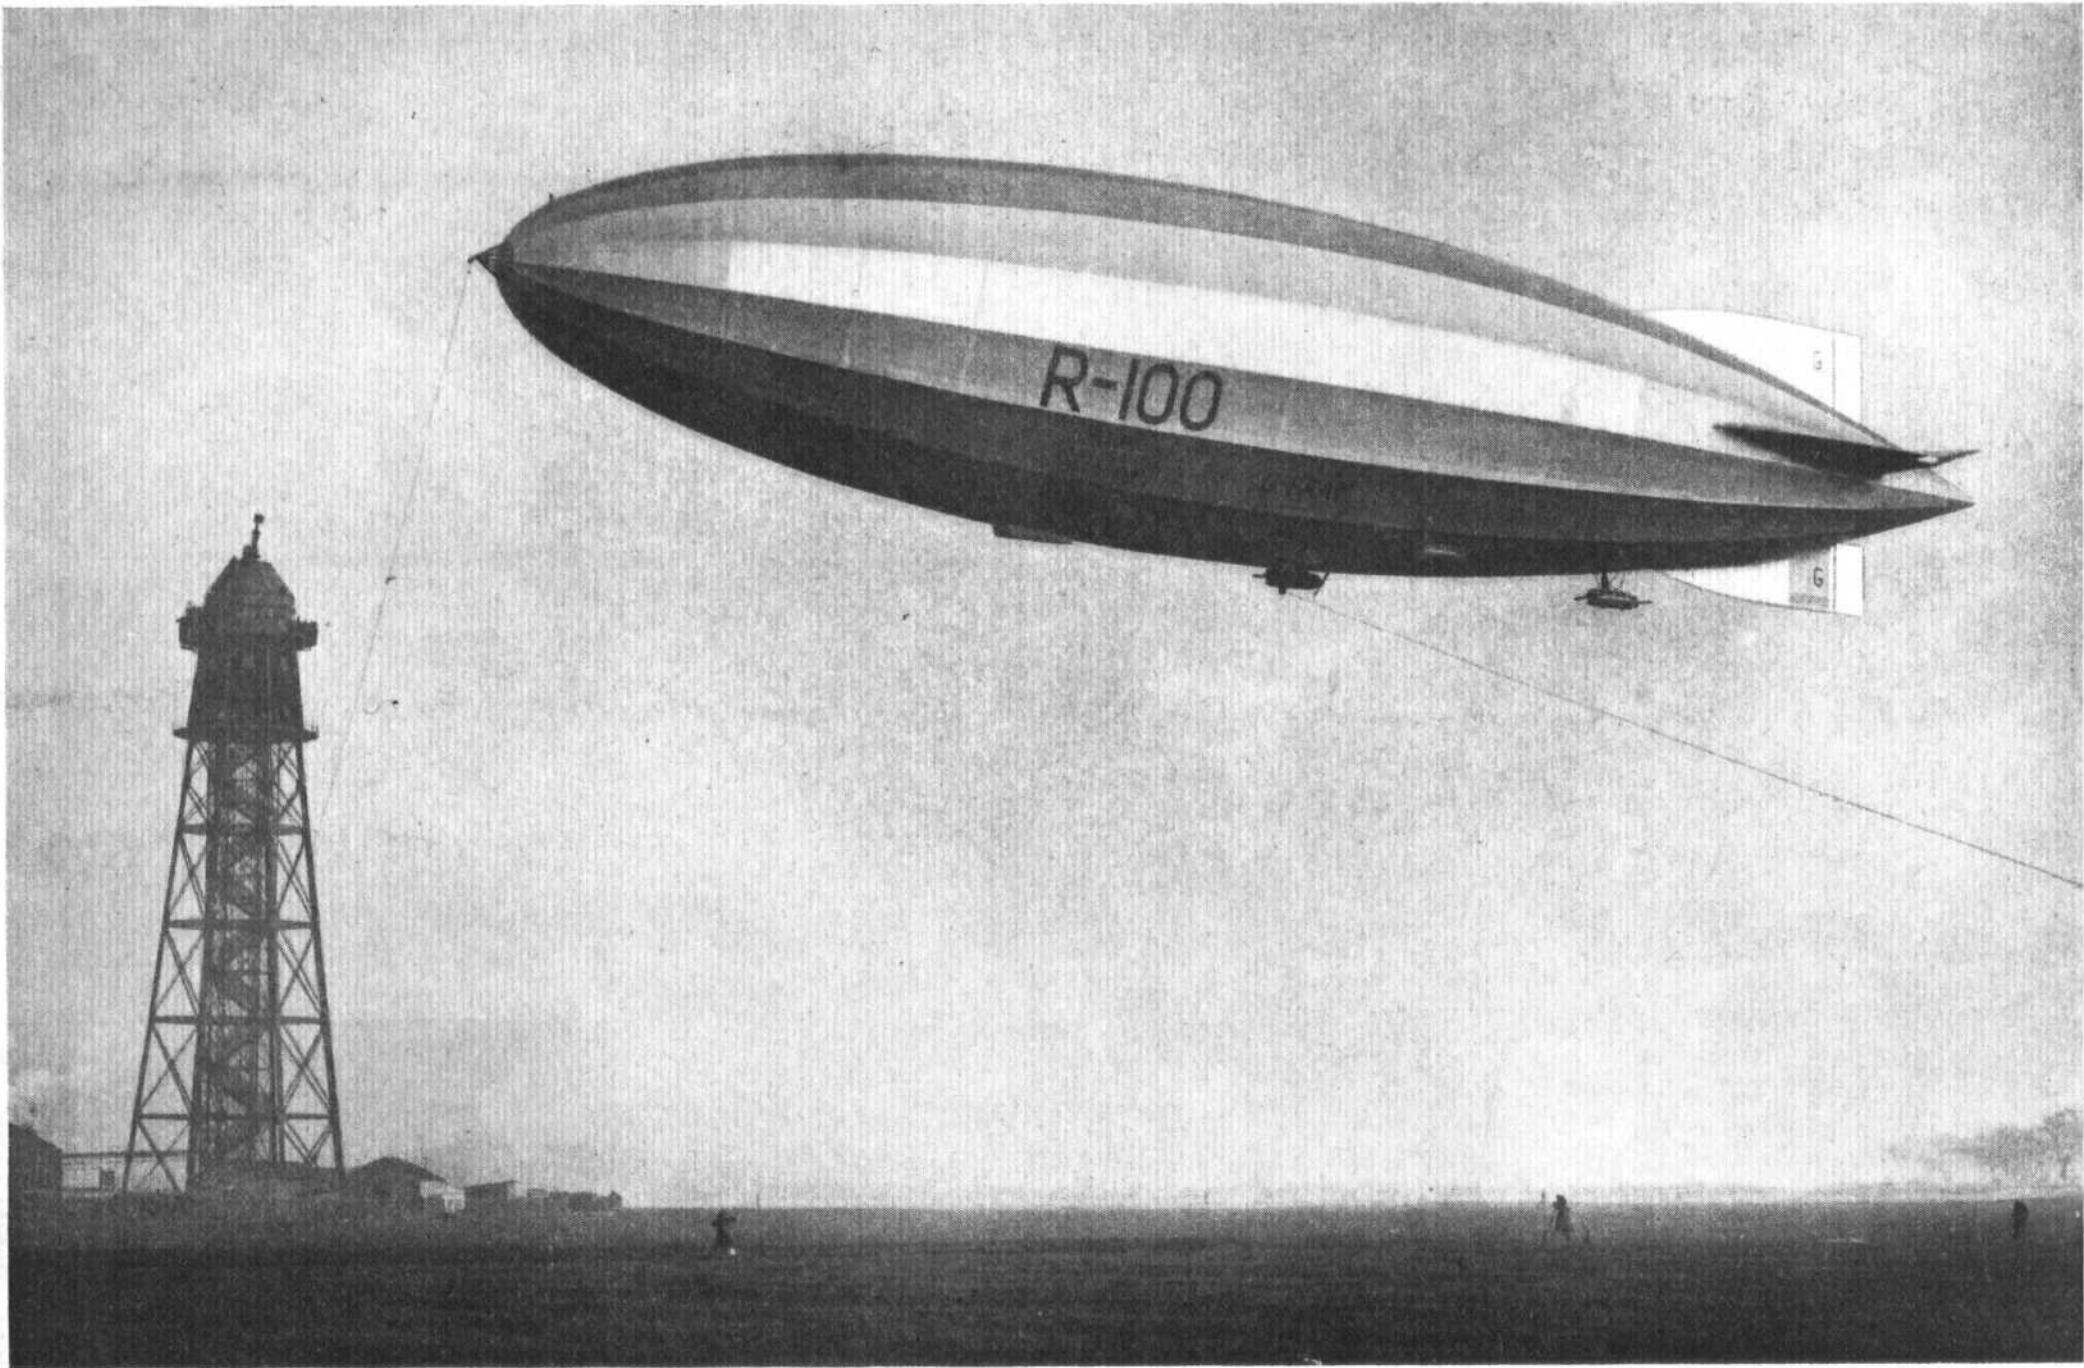
R 100 being hauled down by the tower winch at Cardington. Note the angle of the movable arm in the head of the tower. When the mooring coupling has been made fast, this arm is locked in a vertical position. (FLIGHT Photo.)
