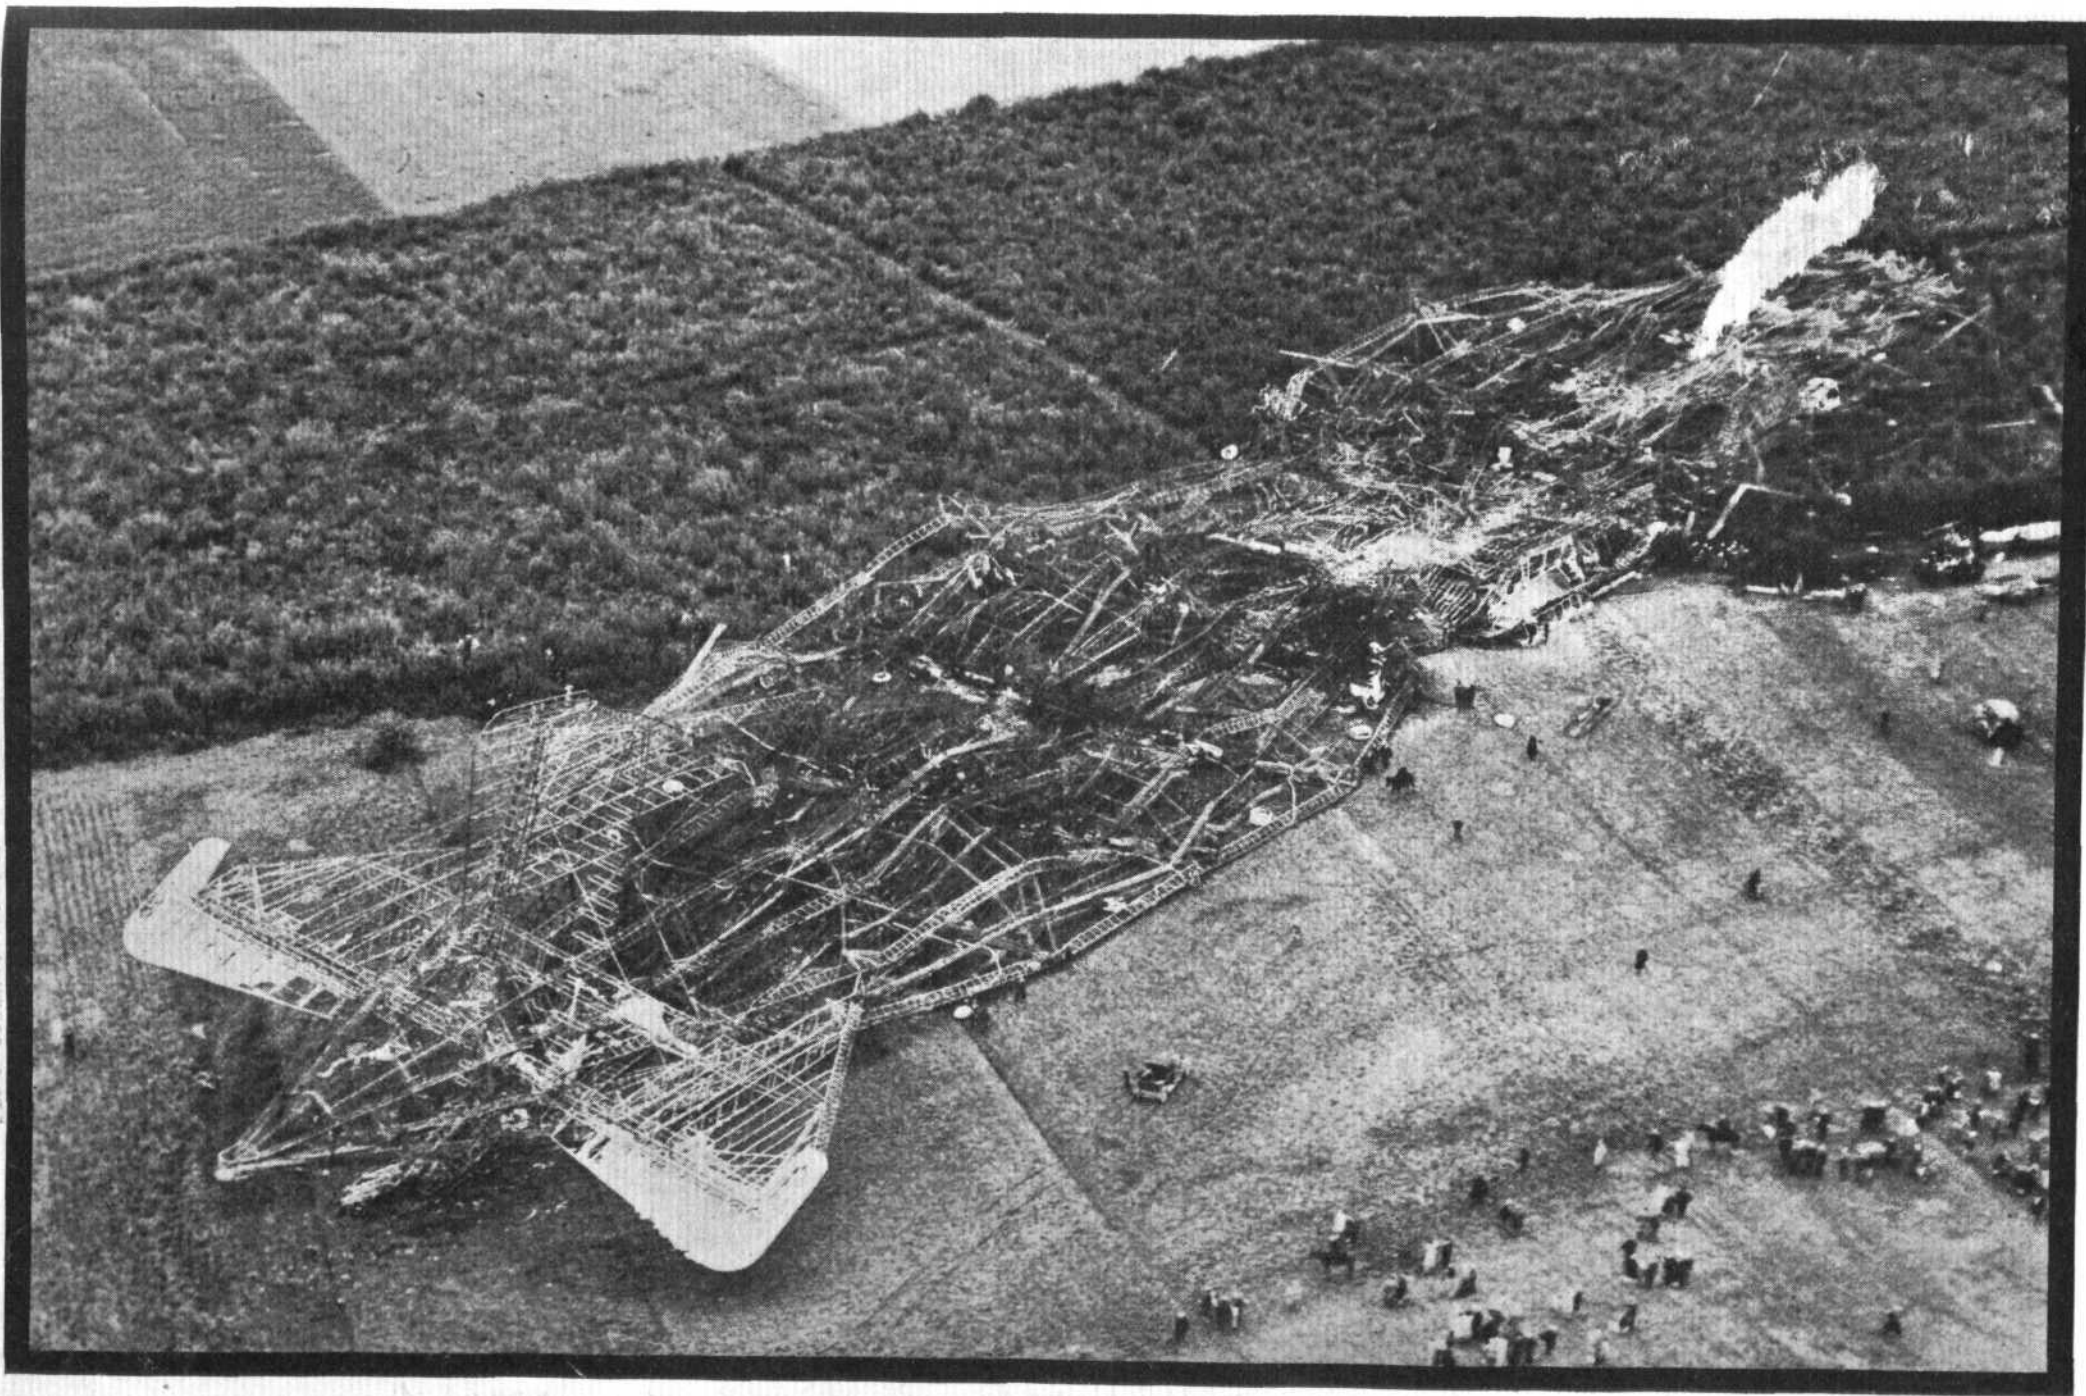
GENERAL AERIAL VIEW OF THE WRECKAGE OF RI01: It will be noticed that the frame is lying in a straight line. The nose has been crushed by impact with the ground, and the most complete destruction has taken place in the bay which supported the passenger coach and the control car. (Photo. "Central News.")
