PREPARE TO DITCH

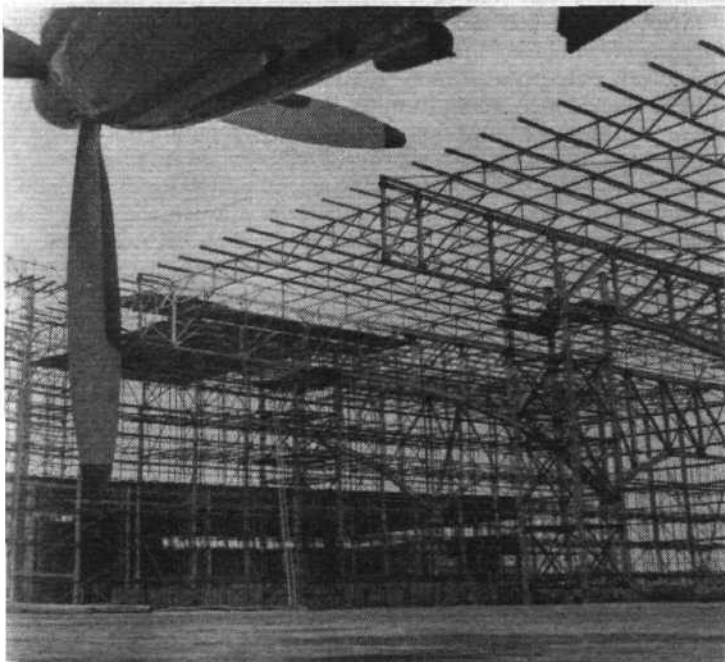
Construction of a vast steel cantilever hangar big enough to accommodate VC10s is now well advanced at British United's maintenance base area at London Gatwick Airport. The first bay is expected to be ready by the end of this year, and provision has been made for three additional bays. The first of BUA's two VC10s on order will soon be delivered
