## Fuel ingestion tests continue drive to get Concorde airborne

# Air France CF6 failure leads FAA to order modifications

## Bomb suspected in explosion on parked Thai 737

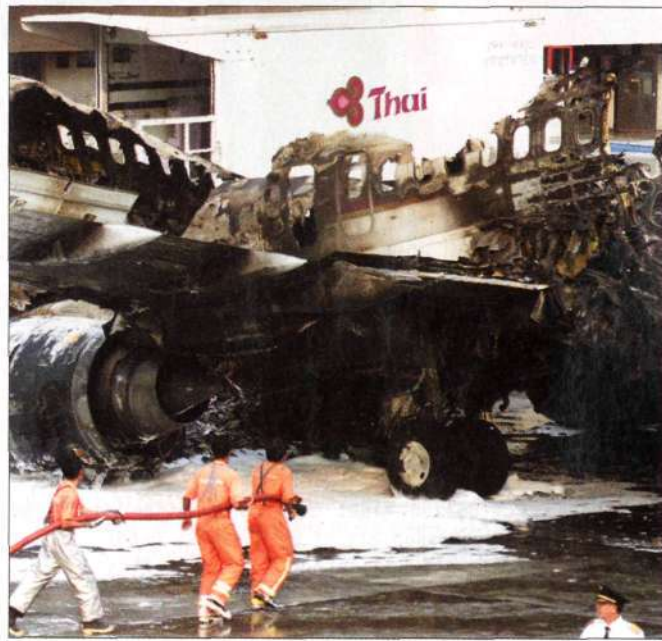
A Thai Airways International Boeing 737-400 has been destroyed, apparently by a bomb, while parked on a stand at Bangkok International Airport on 3 March. One of the cabin crew was killed and seven crew and ground staff were injured.

The explosion and subsequent fire occurred about 35 min before Thailand's Prime Minister Thaksin Shinwatra was due to board the domestic flight to Chiang Mai. Damage suggests the explosion took place somewhere forward of the port wing.
