## PREPARE TO DITCH

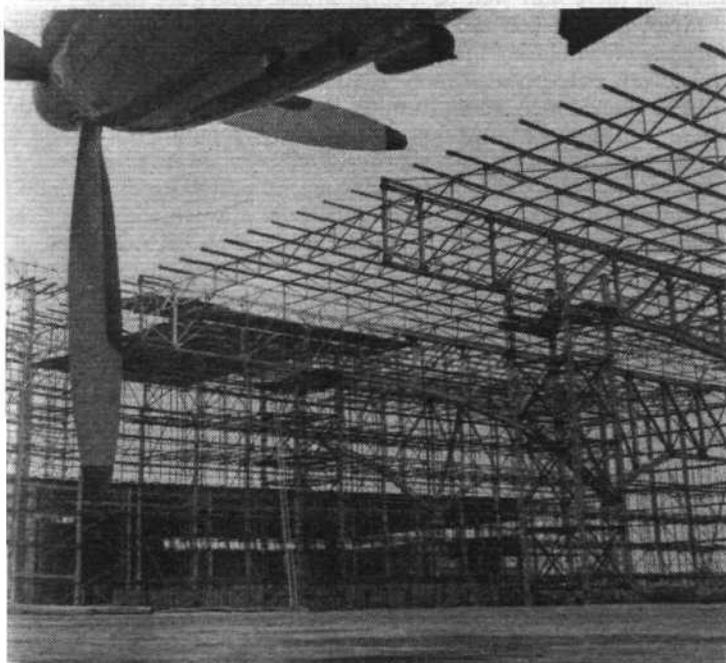
*Construction of a vast steel cantilever hangar big enough to accommodate VC10s is now well advanced at British United's maintenance base area at London Gatwick Airport. The first bay is expected to be ready by the end of this year, and provision has been made for three additional bays. The first of BUA's two VC10s on order will soon be delivered*
